# Water Ponding Duration and It's Impact on Slope Stability-A Case Study of Gunung Batin Toll Road Access

Muhamad Rizki Alamsyah<sup>1\*</sup>, Herwan Dermawan<sup>1</sup>

<sup>1</sup>Civil Engineering Study Program, Indonesia University of Education

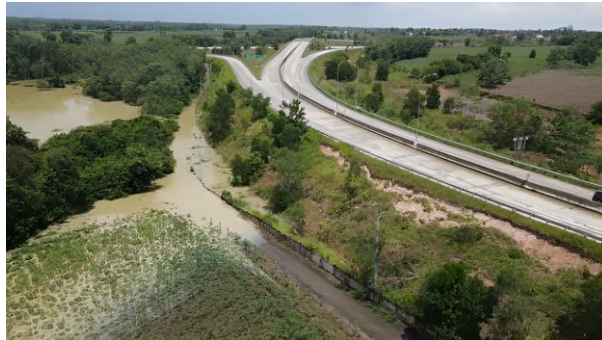
Rainfall- and ponding-induced landslides are common in Indonesia. A notable case occurred along the Terbanggi Besar–Pematang Panggang–Kayu Agung Toll Road (Terpeka Toll Road) at the Gunung Batin access in Lampung. Here, ponding lasted for 19 hours (water level from +16.60 down to +14.50) and caused slope failure at STA. 1+300, as illustrated in Figure 1. This incident highlights the importance of slope stability assessment in areas prone to ponding, especially for infrastructure such as toll roads. Landslides not only endanger road users but also result in major economic losses due to transport disruptions. Ponding has site-specific characteristics, including water depth and duration. Hidayat et al. [18] emphasized that ponding depth affects slope stability, but did not analyze the role of duration. In contrast, Johnston et al. [19] argued that both ponding depth and duration must be considered in slope failure assessments. For this reason, the present study investigates the effect of ponding duration on slope stability and proposes appropriate slope protection measures for STA. 1+300 of the Terpeka Toll Road, Gunung Batin Access.

Fig. 1. Landslide on the Terpeka Toll Road Access to Gunung Batin Sta. 1+300

obstructed water flow at the box culvert, leading to backwater. Therefore, slope protection efforts are required to prevent an increase in pore water pressure due to ponding. One recommended method is the application of impermeable surface layers, such as HDPE geomembrane material.

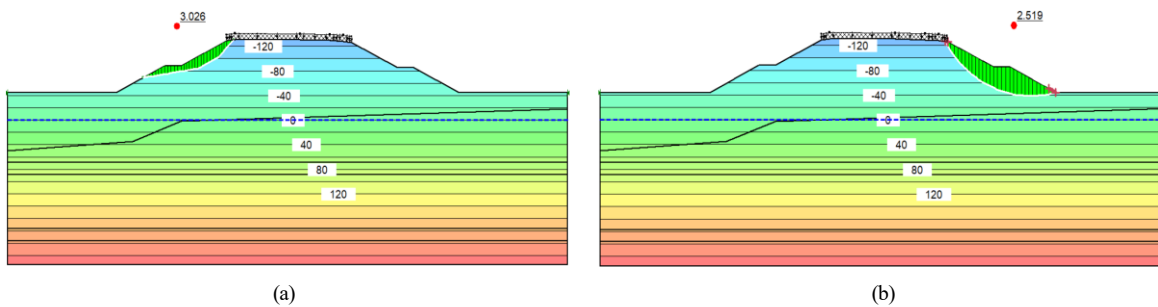
As an example, the results of the SLOPE/W analysis using the Morgenstern-Price method under effective conditions are presented in Fig. 4. Based on the analysis, the FoS value for the left side of the STA. 1+300 slope was  $3.026$ . A similar analysis conducted on the right side of the slope yielded an FoS value of  $2.519$ . A complete summary of all existing condition analyses for the STA. 1+300 slope is presented in Table 2.

Fig. 4. Slope Stability Analysis under Existing Effective Conditions using the Morgenstern-Price Method: (a) Left Slope; (b) Right Slope

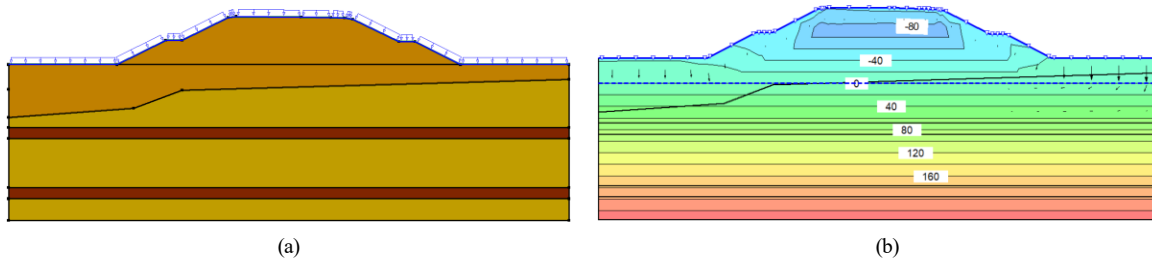
Fig. 5. Seep/w Analysis of Rainfall Influence over 9 Hours: (a) Boundary Condition; (b) Simulation Results

Based on the analysis results, it can be observed that the pore water pressure within the slope increased. This increase was triggered by the infiltration effect of rainfall. Rainfall lasting for 9 hours raised the minimum pore water pressure of the slope to  $-96.205$  kPa, representing an increase of  $34.425$  kPa compared to the existing condition. The slope material at STA. 1+300 consists of clay soil, which is characterized as impermeable and has low permeability, making water flow through it difficult. Consequently, the analysis shows that significant changes in pore water pressure occurred primarily at the surface of the slope. To provide a clearer representation of the pore water pressure distribution, several observation points were established on both the left and right sides of the slope. These observation points were placed at the crest, the mid-slope, and the toe of the slope. The placement of these observation points is illustrated in Fig. 6.

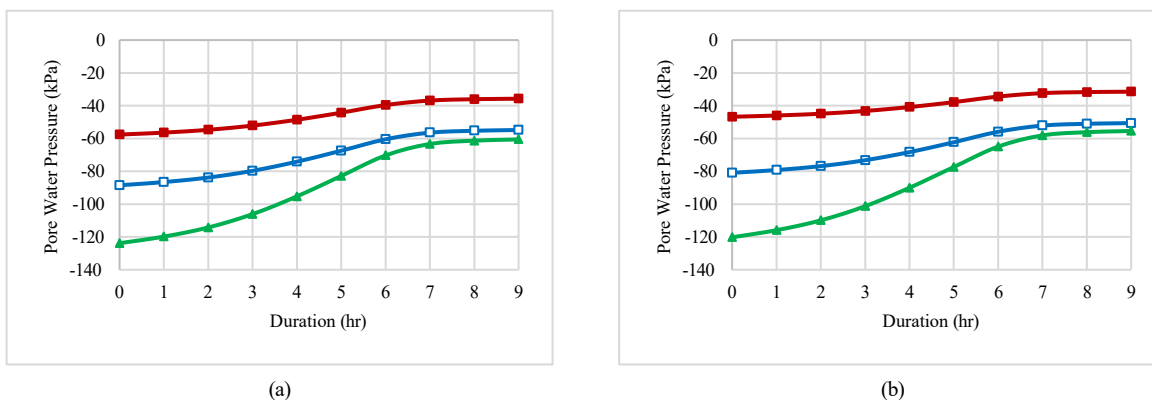
The analysis results indicate that both the left and right sides of the slope at STA. 1+300 experienced an increase in pore water pressure. This increase became more significant with the rising intensity and duration of rainfall. The distribution of pore water pressure values on both the left and right sides of the slope is presented in Fig. 7.

Fig. 7. Distribution of Pore Water Pressure (u) on the Slope Surface Due to Rainfall: (a) Left Slope; (b) Right Slope

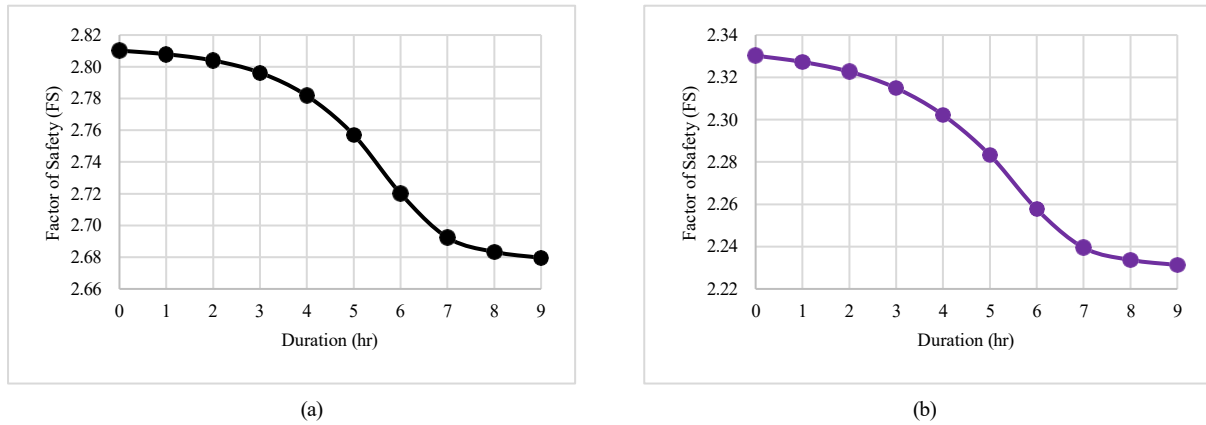
The analysis was then continued using the Slope/W program to evaluate the slope stability under the influence of rainfall. The stability analysis was carried out using the Janbu method, with the slip surfaces defined in the same manner as in the existing condition analysis. The results are presented in graphical form, as shown in Fig. 8. Based on the analysis, it was found that the factor of safety (FS) decreased as the pore water pressure increased in both the left and right slopes at STA. 1+300. However, the FS values under rainfall conditions remained relatively high, with  $FS > 2$ . Therefore, referring to the same criteria applied in the previous analysis, the slope at STA. 1+300 is still considered stable and safe.

Fig. 8. Factor of Safety Analysis Under 9-Hour Rainfall: (a) Left Slope; (b) Right Slope

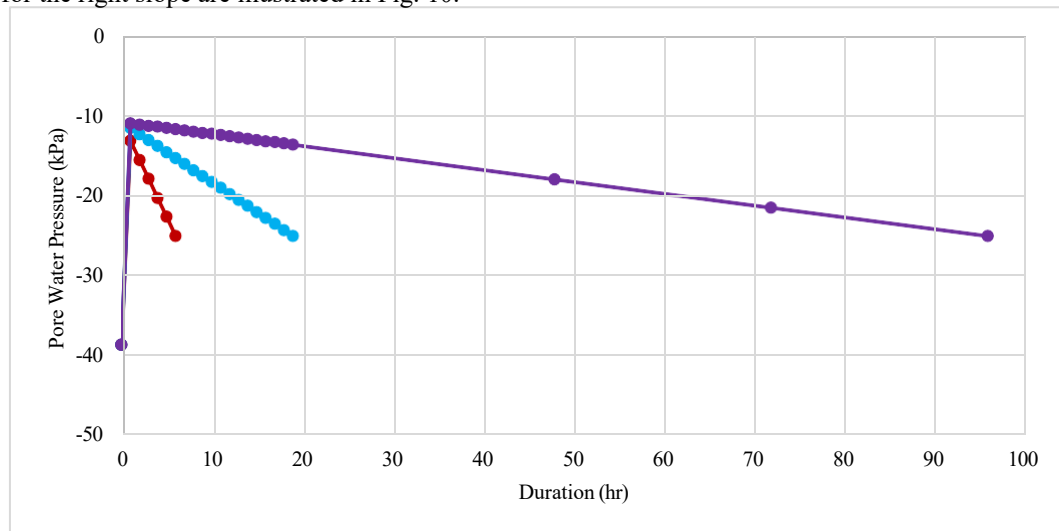
Fig. 9. Results of Seep/W Analysis of the Effect of Ponding Duration Variations on the Left Slope

Based on the analysis results for the left slope, as shown in the graph, it can be observed that the duration of ponding significantly affects the pore water pressure values. For comparison, the Seep/W analysis results at the 6th hour show that the pore water pressure values for ponding durations of 6 hours, 19 hours, and 4 days were  $-25.064$  kPa,  $-15.323$  kPa, and  $-11.7$  kPa, respectively. These results indicate a considerable difference among the three conditions. The greatest increase in pore water pressure occurred in the 4-day ponding analysis, while the smallest increase was observed in the 6-hour ponding analysis. Therefore, it can be concluded that the longer the ponding duration, the higher the pore water pressure on the slope at STA. 1+300.

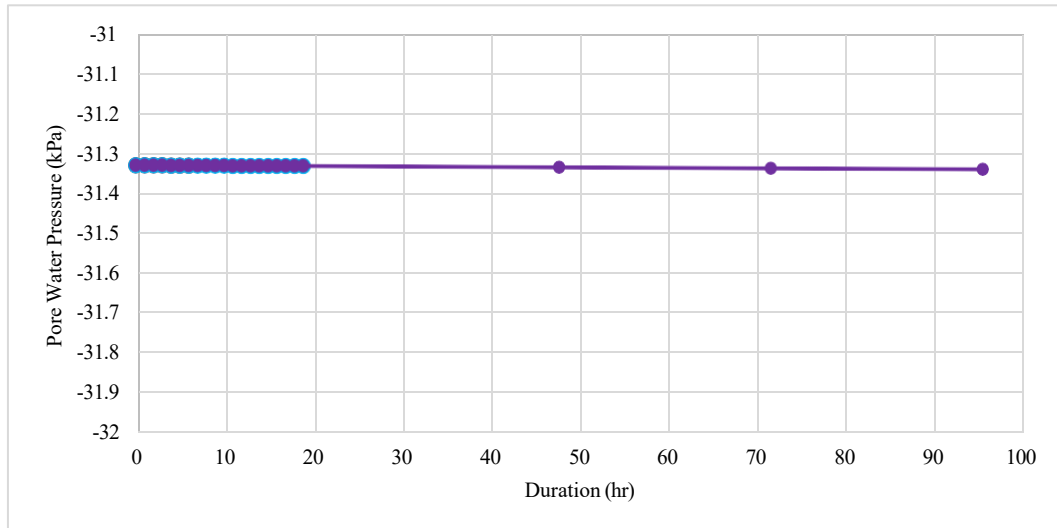
Fig. 10. Results of Seep/W Analysis of the Effect of Ponding Duration Variations on the Right Slope

On the other hand, the analysis of the right slope shows no significant changes in pore water pressure values due to ponding on the left slope. Even ponding lasting up to 4 days did not affect the right slope. This condition is attributed to the clay soil characteristics of the slope, which make water infiltration and flow extremely difficult. Consequently, the right slope remained unaffected.

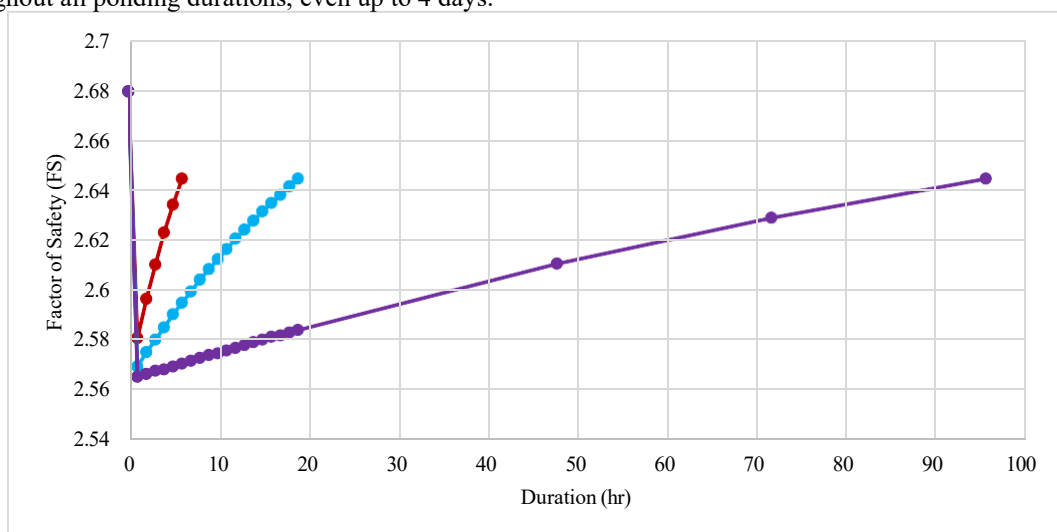
The analysis was then continued using the Slope/W program to evaluate slope stability under ponding conditions, both on the left and right slopes. The results are presented in Fig. 11 for the left slope and Fig. 12 for the right slope. The findings show that, at the 6th hour of ponding, the factor of safety (FoS) on the left slope varied depending on the ponding duration. The FoS values for ponding durations of 6 hours, 19 hours, and 4 days were 2.644, 2.595, and 2.57, respectively. It is evident that the 4-day ponding duration resulted in the lowest FoS, while the 6-hour duration yielded the highest. This trend is inversely proportional to the pore water pressure values obtained from the ponding duration variations. Meanwhile, the FoS on the right slope remained unchanged throughout all ponding durations, even up to 4 days.

Fig. 11. Slope/W Analysis Results of the Effect of Ponding Duration Variations on the Left Slope

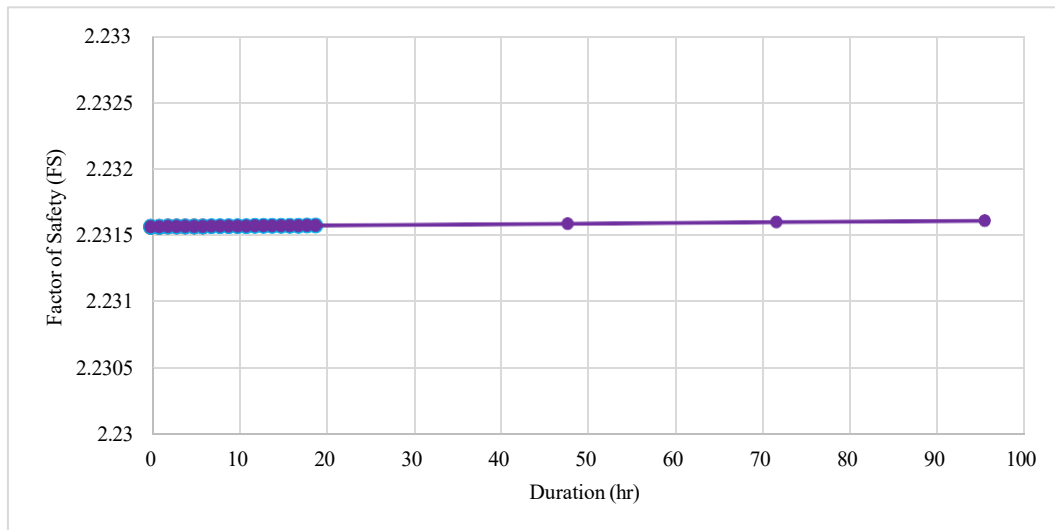
Fig. 12. Slope/W Analysis Results of the Effect of Ponding Duration Variations on the Right Slope

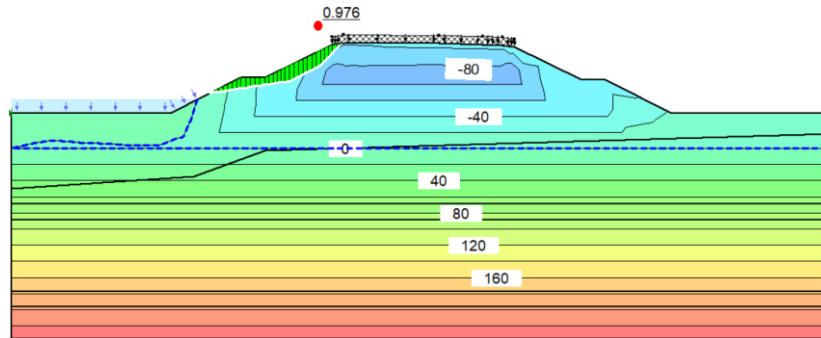
Fig. 13. Landslide Analysis Results on the Slope at STA. 1+300

The results of the analysis are considered to represent the landslide condition at STA. 1+300. Based on the previous analysis, it was found that the soil reached its highest level of saturation during the first hour of ponding. Therefore, at this duration, the slope at STA. 1+300 is assumed to have experienced failure. Figure 13 shows that the slope safety factor (SF) was 0.976 at the time of failure. This value was obtained through a reduction of the soil shear strength parameters ( $c'$  and  $\phi'$ ) by 31% from the initial estimated values, resulting in  $c' = 2.51$  kPa and  $\phi' = 17^\circ$  during the landslide event.

According to Purba et al. [22], slope protection methods must be implemented based on the mechanism of landslide occurrence. On a slope, two primary forces act simultaneously, namely the driving force and the resisting force. The driving force is the tangential force generated by the weight of the soil/rock mass, while the resisting force is the shear resistance of the soil/rock. Slope failure occurs when the driving force exceeds the resisting force. Therefore, the principle of slope failure mitigation is to reduce the driving force and/or increase the resisting force. The landslide at the Terpeka Toll Road, Gunung Batin Access STA. 1+300, is assumed to have occurred due to ponding at the toe of the left slope. This ponding was caused by the overflow of the Way Terusan River, which obstructed water flow at the box culvert and resulted in backwater. The ponding condition increased pore water pressure and, due to the direct contact between ponded water and the slope soil, led to a reduction in soil strength. As the soil strength decreased, the slope lost its resisting capacity, thereby triggering slope failure along this section of the road. Consequently, the most appropriate slope protection method is to cover the slope surface with impermeable materials to prevent water infiltration into the slope body, thereby stabilizing pore water pressure and maintaining soil strength. One effective method is the application of geosynthetic materials, particularly geomembranes. Various types of geomembranes are available, such as High-Density Polyethylene (HDPE), Low-Density Polyethylene (LDPE), and Polyvinyl Chloride (PVC). In Indonesia, HDPE geomembranes are most commonly used because of their resistance to corrosion, ultraviolet radiation, and chemical exposure.
