Analysis of Road Damage Treatment (Case Study: National Road Segment Bts. Kab. Subang/Karawang – Bts. Kota Pamanukan STA 2350 – STA 3352)

Abdu Somad Rajabilah^{1*}, Juang Akbardin¹, Yudi Sekaryadi¹

¹Civil Engineering Study Program, Indonesia University of Education

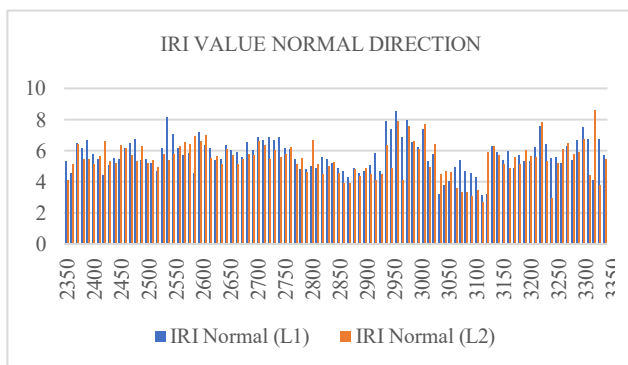
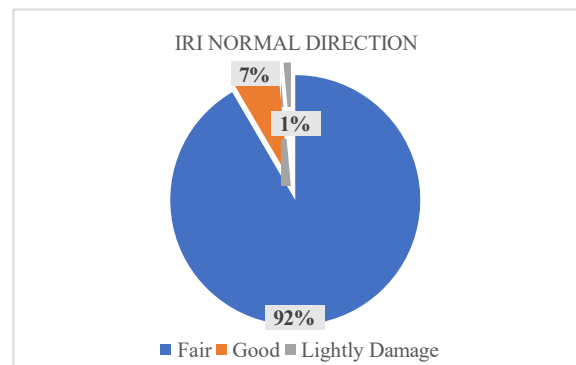
Figure 4. IRI Value Graph – Normal Direction

Based on the two presented graphs and diagram, it was found that the highest IRI value occurred at STA 3340–3350 in the normal direction (L2) with an IRI of 8,58, while the lowest IRI value was recorded at STA 3260–3270 in the normal direction (L2) with a value of 2,92. The majority of IRI values—92%—for the BTS. Kab. Subang/Karawang – BTS. Kota Pamanukan road segment in the normal direction fall within the Fair condition category.

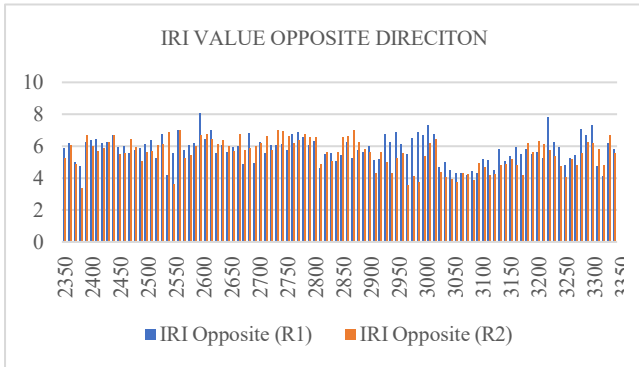
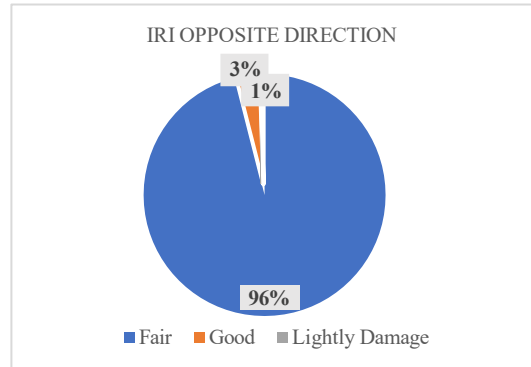
Figure 6. RCI Value Graph – Opposite Direction

Based on the presented graphs and diagram, it was found that the highest IRI value occurred at STA 2600–2610 in the normal direction (R1) with an IRI of 8,09, while the lowest IRI value was recorded at STA 2380–2390 in the normal direction (R2) with a value of 3,35. The majority of the IRI values—96%—for the BTS. Kab. Subang/Karawang – BTS. Kota Pamanukan road segment in the opposite direction fall within the Fair condition category.

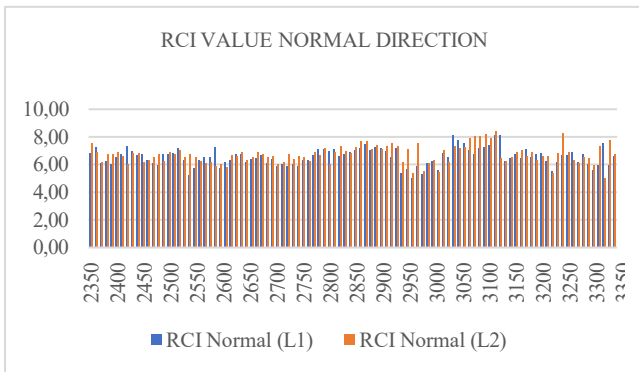
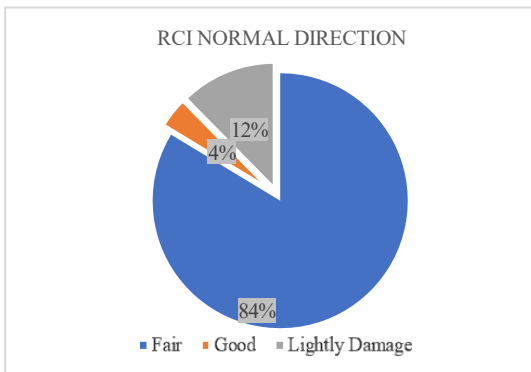
Figure 8. RCI Value Graph – Normal Direction

Based on the presented graphs and diagram, it was found that the highest RCI value occurred at STA 3130–3140 in the normal direction (R2) with an RCI value of 8,45, while the lowest RCI value was recorded at STA 3340–3350 in the normal direction (R2) with a value of 5,01. The largest percentage of RCI conditions—84%—for the BTS. Kab. Subang/Karawang – BTS. Kota Pamanukan road segment in the normal direction falls into the Fair condition category.

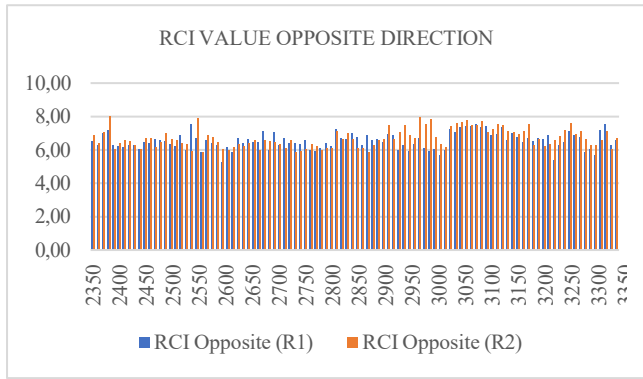
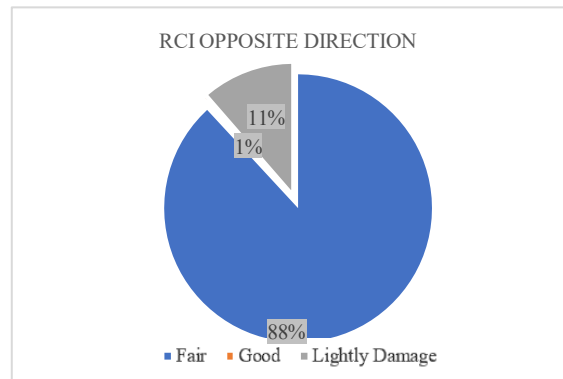
Figure 10. RCI Value Graph – Opposite Direction

Based on the presented graphs and diagram, it was found that the highest RCI value occurred at STA 2380–2390 in the normal direction (R2) with an RCI value of 8,03, while the lowest RCI value was recorded at STA 2600–2610 in the normal direction (R1) with a value of 5,26. The largest percentage of RCI conditions—88%—for the BTS. Kab. Subang/Karawang – BTS. Kota Pamanukan road segment in the opposite direction falls into the moderate condition category.

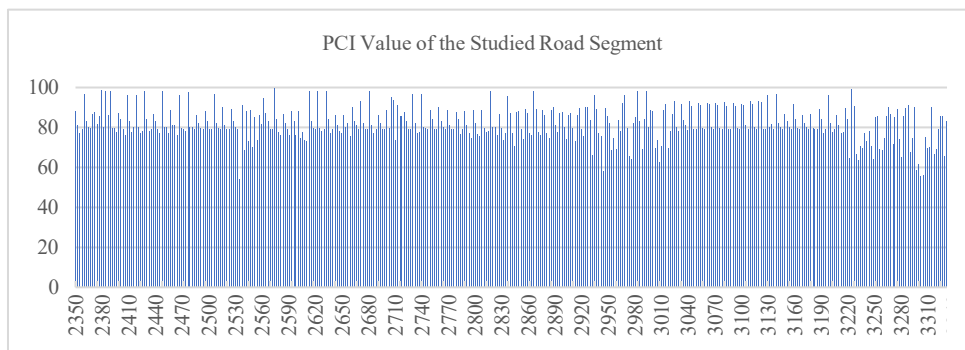
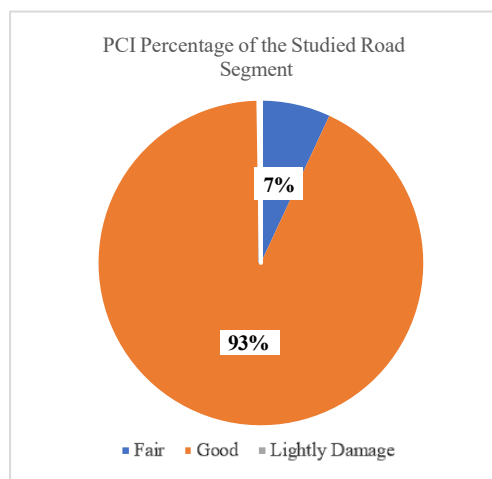
Figure 12. PCI Value Graph – Opposite Direction

The PCI values obtained from the pavement condition survey range from 53,9 to 99,5. The lowest PCI value, 53,9, was found at STA 2350–2360, while the highest PCI value, 99,5, was recorded at STA 3350–3352. The average PCI value is 81,96, indicating that the road is in good condition. The PCI values for the road segment are illustrated in the graph shown in the following figure:

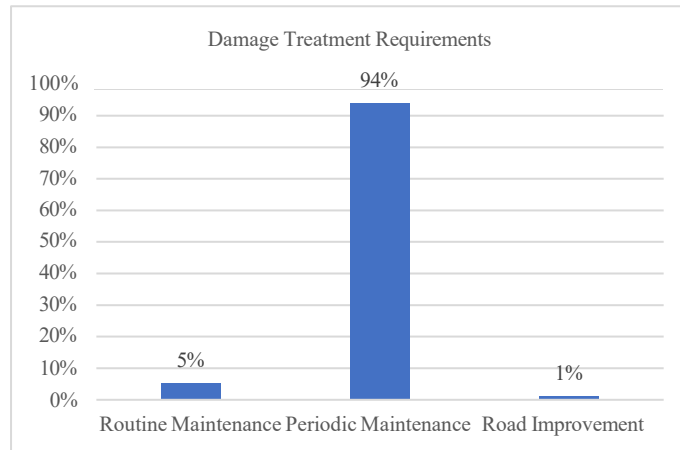
Figure 14. Percentage of Road Damage Treatment Needs

From the figure, it is shown that 94% of the segments require periodic maintenance. Therefore, the appropriate treatment that can be implemented is through overlay planning.

Thus, it was determined that an additional overlay thickness of 11 cm is required to improve the pavement on the road section from BTS. Kab. Subang/Karawang to BTS. Kota Pamanukan.
