Assessment of Remaining Service Life Prediction and Bridge Rehabilitation Recommendations Using Bridge Management System and Phenolphthalein (C₂₀H₁₄O₄) (A Case Study: Cimanuk Maktal Bridge, Garut, West Java)

Muhammad Fikri Aulawi¹, Beny Mulyana Sukandar¹, Ida Farida²

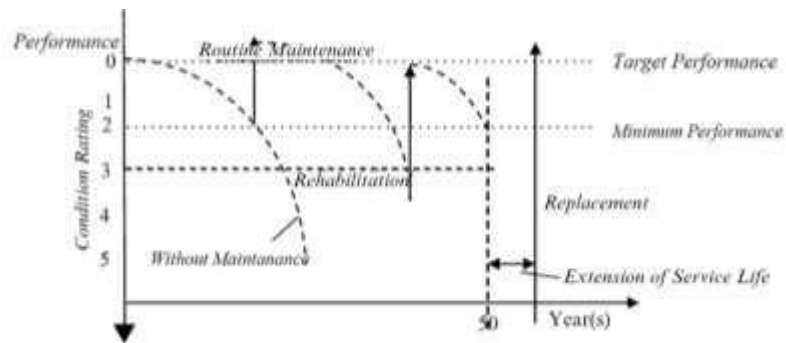
Figure 1. Bridge Remaining Service Life Diagram

The remaining service life of a bridge is influenced by its condition, while the condition itself is determined by the extent of structural damage. Bridge performance gradually declines over time as it continues to carry traffic loads, which means that as the bridge ages, the demand for proper intervention increases. Therefore, it is essential to conduct an analysis of the bridge's age and remaining service life by referring to the Guidelines for Bridge Preservation Management issued by the Directorate General of Highways (Dirjen Bina Marga), using the following equation [6]:

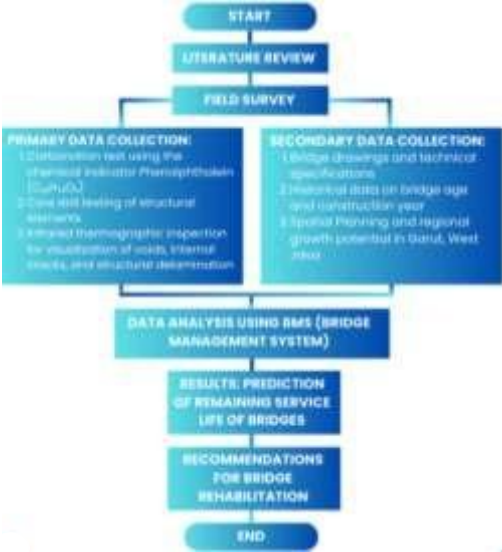
Figure 2. Research Methodology

The research methodology applied in this study consists of several stages. The first stage was the collection of samples at the study site, followed by testing the concrete condition of the bridge and capturing infrared thermographic images. The final stage of the research involved BMS analysis to evaluate the prediction of the bridge's remaining service life [7]. In summary, the research methodology employed is illustrated in Figure 2.

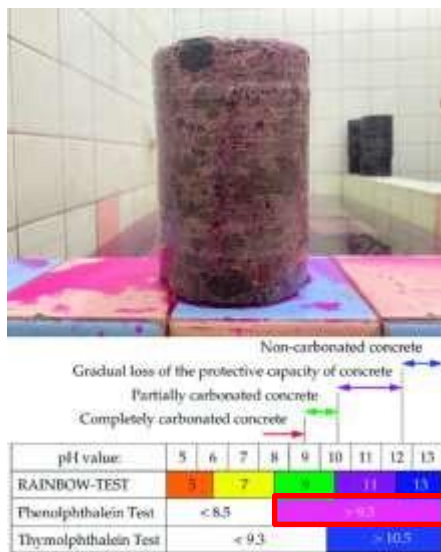
Figure 4. Sampel 1 - A1
(Cimanuk Maktal Bridge I)

4.3 In the carbonation test of concrete, areas that remain in good condition (still alkaline) will turn pink/purple, whereas areas that have undergone carbonation, with a pH lower than 8 (acidic), will show no color change

Based on Figure 10, the results of the carbonation test using Phenolphthalein (C₂₀H₁₄O₄) on the Cimanuk Maktal I Bridge, Garut Regency, show that section A1 (Abutment) has a pH value of 10.7 – Alkaline, P1 (Pier) has a pH value of 6.8 – Acidic, and A2 (Abutment) has a pH value of 11.2 – Alkaline. For the Cimanuk Maktal II Bridge, Garut Regency, section AB1 (Abutment) has a pH value of 10.2 – Alkaline, PL1 (Deck Slab) has a pH value of 11.5 – Alkaline, and AB2 (Abutment) has a pH value of 7.5 – Acidic. It can be concluded that section P1 (Pier) with a pH value of 6.8 on the Cimanuk Maktal I Bridge and section AB2 (Abutment) with a pH value of 7.5 on the Cimanuk Maktal II Bridge have concrete that is contaminated by an acidic environment
