# Water Ponding Duration and It's Impact on Slope Stability-A Case Study of Gunung Batin Toll Road Access

Muhamad Rizki Alamsyah<sup>1\*</sup>, Herwan Dermawan<sup>1</sup>

<sup>1</sup>Civil Engineering Study Program, Indonesia University of Education

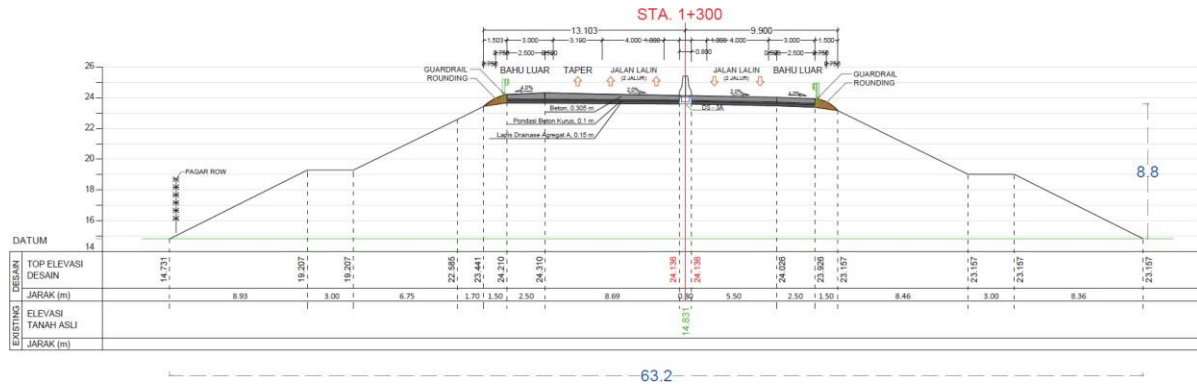
Fig. 2. Cross-Sectional Profile of the Slope at STA. 1+300

Based on the site plan data, the cross-sectional profile of the slope at STA. 1+300 was obtained, as illustrated in Figure 2. The slope has an approximate height of  $\pm 8.8$  m and a width of  $\pm 63.2$  m.

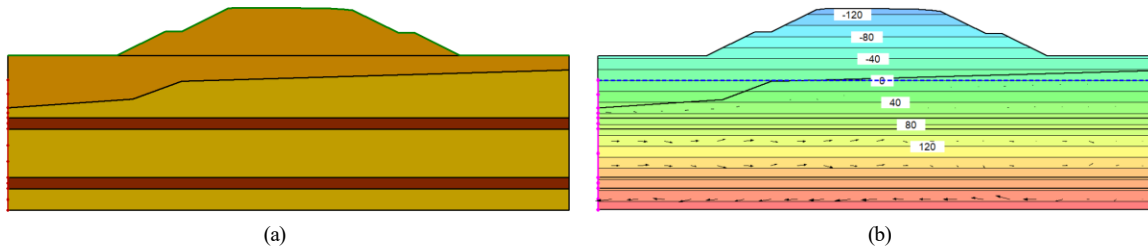
Fig. 3. SEEP/W Analysis of Existing Conditions: (a) Boundary Condition Analysis; (b) Simulation Results

Based on the analysis results, the pore water pressure values at the STA. 1+300 slope under existing conditions were obtained. The zone above the groundwater table represents a negative pore water pressure zone, with a minimum value of  $-130.63$  kPa. Conversely, the zone below the groundwater table exhibits positive pore water pressure, with a maximum value of  $235.37$  kPa. The deeper the soil layer, the higher the pore water pressure value [20]. The analysis was then continued using the SLOPE/W program to evaluate slope stability through the factor of safety (FoS). The analysis was performed on both the left and right sides of the slope using the Morgenstern-Price, Bishop, Janbu, and Ordinary methods. The potential slip surface was modeled using the fully specified method for the left side of the slope and the entry-exit method for the right side. A uniform surcharge load of  $37.22$  kPa was applied to the slope surface in the stability analysis. The analyses were conducted under both total (undrained) and effective (drained) conditions.

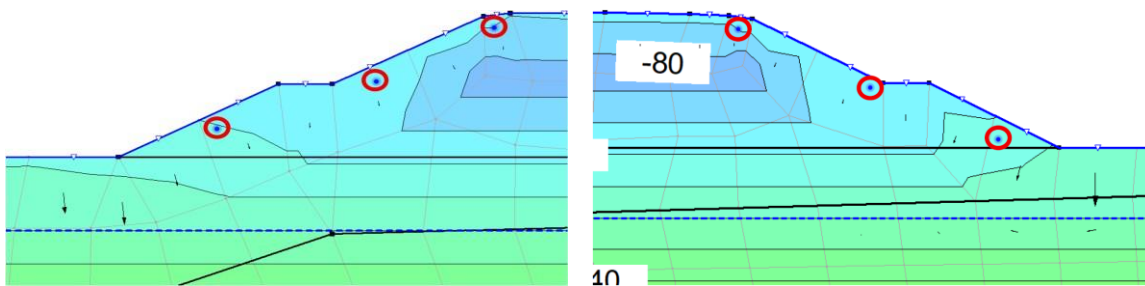
Fig. 6. Observation Points on the Slope at STA. 1+300

The analysis results indicate that both the left and right sides of the slope at STA. 1+300 experienced an increase in pore water pressure. This increase became more significant with the rising intensity and duration of rainfall. The distribution of pore water pressure values on both the left and right sides of the slope is presented in Fig. 7.
