Problem Factors in Supervision and Checking of the Sample House and Fence Construction Project in Samera Djohor, Deli Serdang Regency

¹PT. Samera Propertindo,

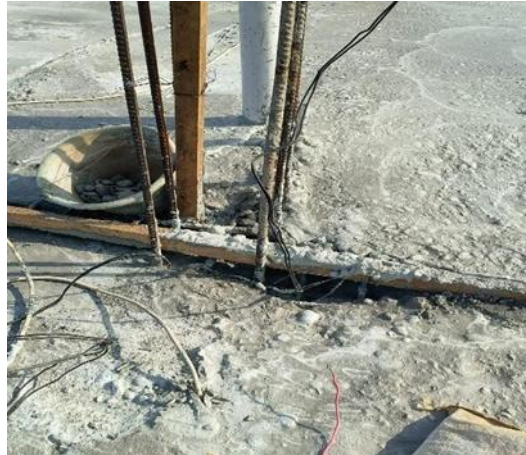
Fig. 2. Kolom K1B as 1B2

Column K1B and axle 1B2 experienced bubbles and dimensional changes. The southern section of the column leaned to the left, appearing twisted. This was due to a lack of verticality checks after casting, resulting in the formwork not being adjusted under pressure. This resulted in the concrete hardening, resulting in bubbles and dimensional changes. This was also due to the formwork being unsuitable for use.

The solution for columns experiencing bubbles is to first chip or drill the column until the reinforcement is visible. Next, clean the area thoroughly. Then, patch the column with a mixture consisting of floor hardener and WP bitumen liquid. Cure the area.

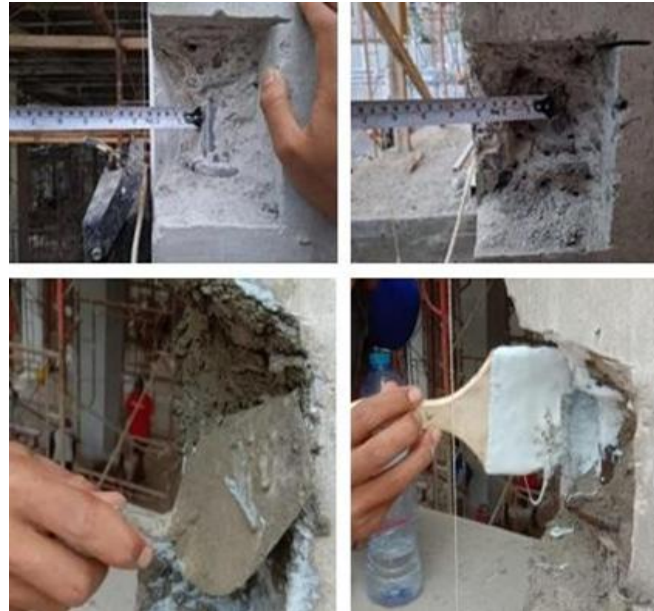
Fig. 4. Segregation and Porous Beams

A beam structure is a structural element that receives forces acting transversely to its axis, resulting in bending moments and shear forces along its span. Beams are structural elements that transfer loads from floor slabs to columns as vertical supports. Beam structural work often experiences segregation and porosity, resulting in visible reinforcement. This occurs due to prolonged use of a concrete vibrator at a specific point.

The solution to the segregation problem that occurs in beams is grouting, the process of filling the gaps or spaces between structural elements with a liquid mixture, usually called grout. Grouting can be made from a mixture of cement, sand, and water, or certain chemicals, depending on the needs. The first stage of grouting is as follows:

- a) Surface chipping
Beams experiencing segregation are cleaned or crushed until the unsegregated part of the beam is reached.
- b) Material selection
The selection of grouting materials must be appropriate. Grouting materials consist of floor hardener and liquid WP bitumen.

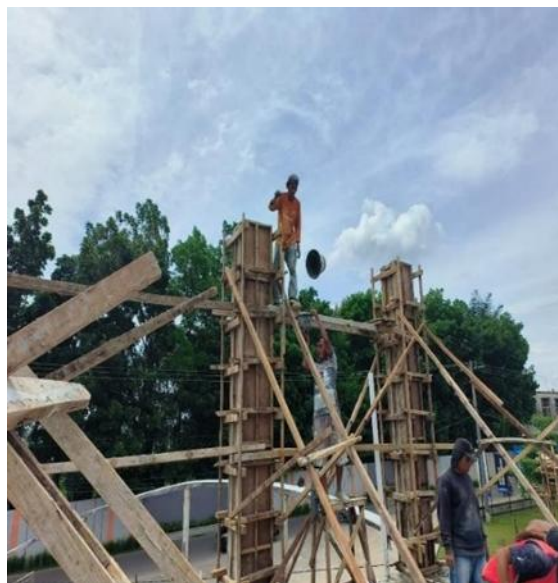
Fig. 5. Concrete Pump

Currently, ready-mix concrete is widely used for casting work, and the equipment required to support this activity is a concrete pump truck, which functions to transport the concrete to the casting area. Problems with the casting work include obstacles due to incorrectly ordered concrete pump types. Due to the difficult-to-reach casting location, column casting was delayed, resulting in beam and slab work progressing to reinforcement work. During casting, obstacles occurred because the concrete vibrator had difficulty entering the columns due to the slab and beam reinforcement.

To prevent problems with casting work from recurring, the first step is to estimate the distance between the casting location and the concrete pump to determine whether the concrete pump pipe reaches the casting location.

If the concrete vibrator is difficult to penetrate, the worker can loosen the iron slightly to create a gap for the vibrator to enter. If the vibrator cannot reach the base of the column, use a wall vibrator to ensure a more even concrete mix.

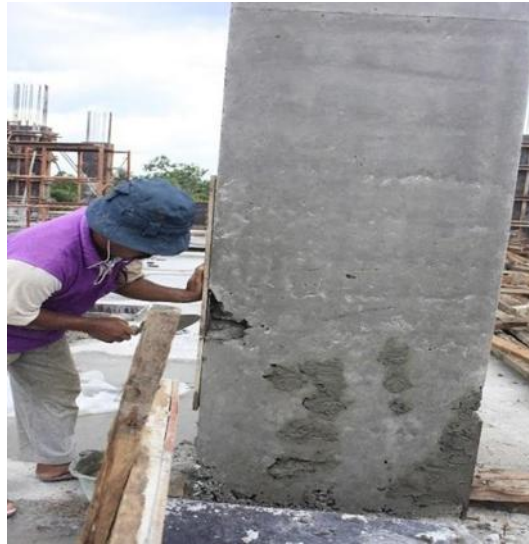
Fig. 6. Column Repair

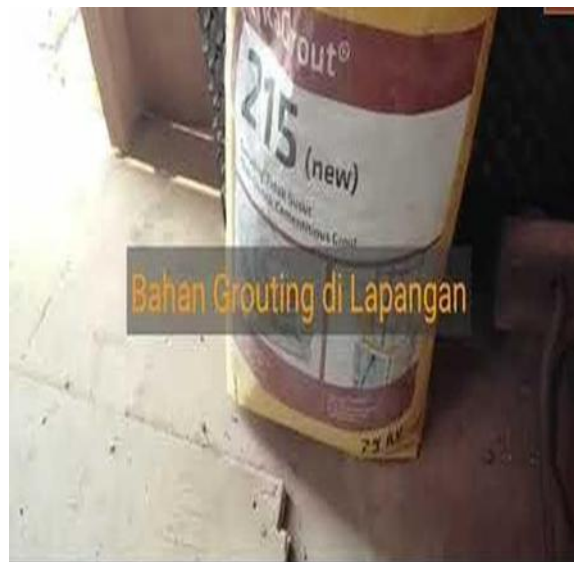
Fig. 7. Grouting Materials

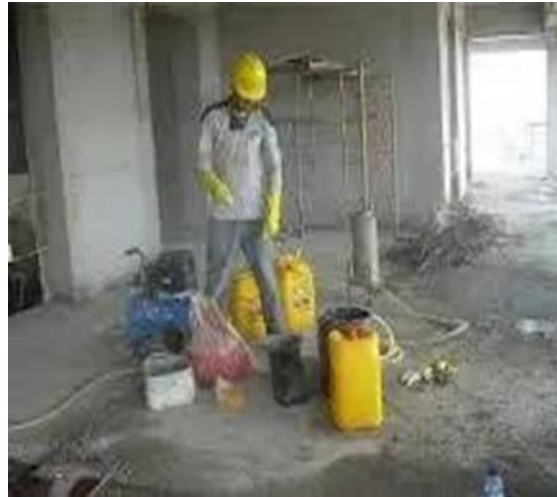
Fig. 8. Mixing Mixture

- c) Prepare the grouting mixture.
After selecting the appropriate ingredients, mix them according to the instructions to achieve optimal results.

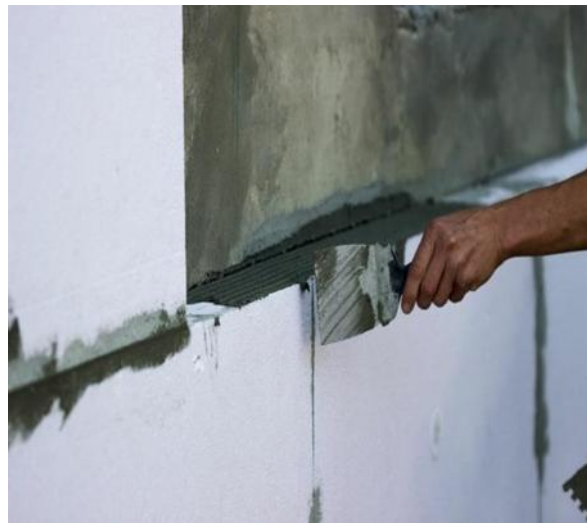
Fig. 9. Apply Grouting

After mixing the ingredients, it can be directly applied to the concrete blocks that have experienced segregation. If it is not applied immediately, the mixture of ingredients will harden. Before applying the blocks, WP bitumen liquid is applied first.

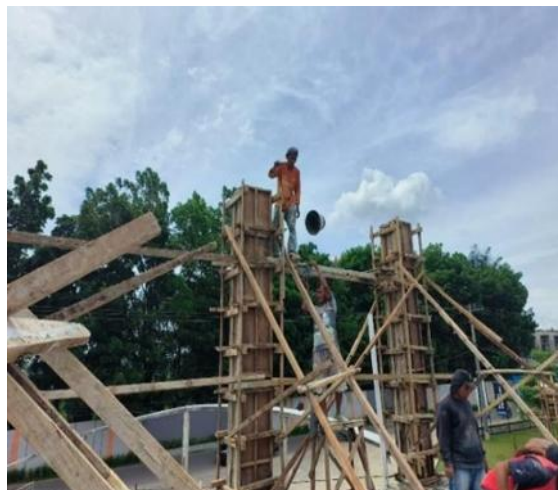
Fig. 10. Casting Using a Concrete Pump
